# CLIMATE DETECTIVES 2022-2023

Coastal researchers  
1st Experimental Junior High School

**What factors contribute to the erosion of the northern coast of Chania.**

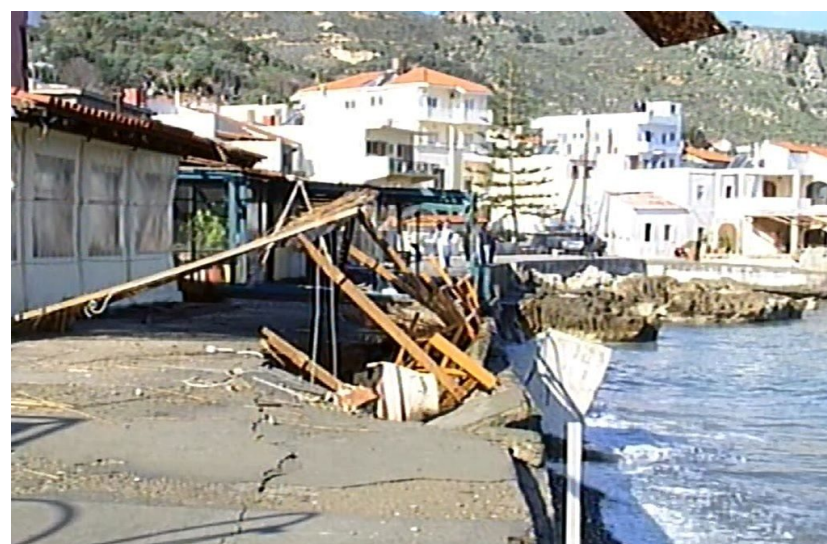
Figure 1: Disasters from coastal erosion in the port of Kolymbari

The following satellite images concern the port of Columvari. The port in the settlement of Kolymbari has suffered serious damage in previous years due to coastal erosion. The first image depicts the port in 2019, while the second in 2022. Initially, it is evident that there are 3 new, parallel to the shore cantilevers. Second change that exists in the image of 2022 is that the port has been artificially expanded. The last change that is observed is that the harbor has small curves around the coastline, meaning that the shape of the coastline has changed at a rapid pace. The survey showed that the new harbor works to protect Kolymbari were completed in spring 2021.

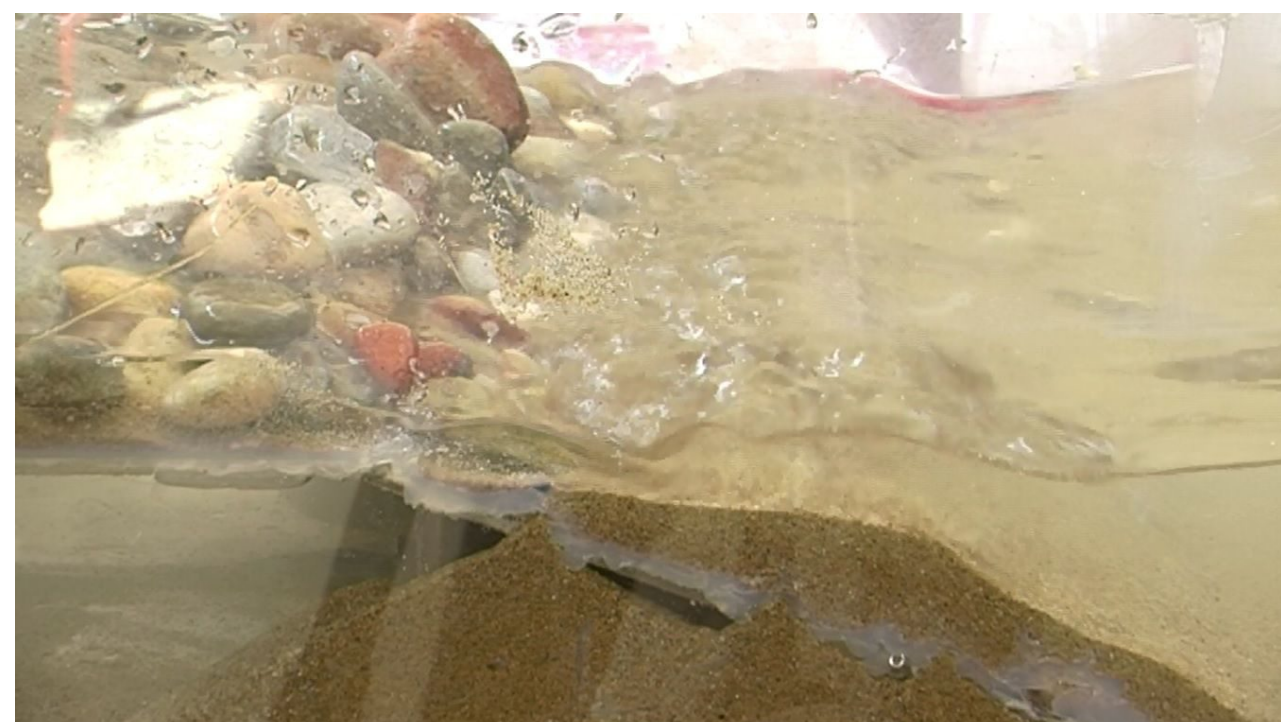
Figure 3: Coastal erosion study model for future and detailed study of the phenomenon

In order to study the phenomenon more deeply, we built a study model of coastal erosion. In the future, using this study model of coastal erosion, we intend to study the individual phenomena that explain coastal erosion, how these phenomena evolve and we are going to calculate the pace at which the shape of a coast changes.
