# CLIMATE DETECTIVES 2021 – 2022

Flash Floods Children  
7th Junior High School of Ilioupoli

**How are floods created and what are their effects on the local community of Ilioupoli? What can we do to deal with this issue?**

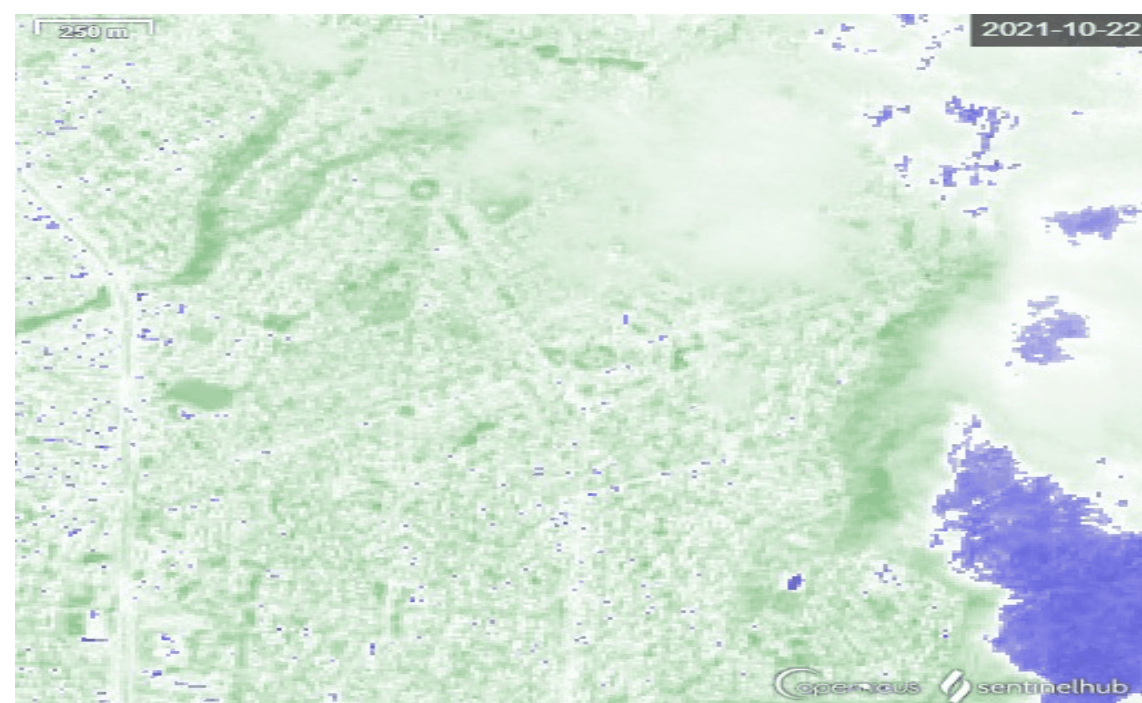
Figure 1: Timelapse of Ilioupoli mapping the areas of water body collection during rainy days

We analyzed data from the Hellenic National Meteorological Service (H.N.M.S), for a timeseries of 30 years (1991-2020). We studied the Normalized Difference Water Index (NDWI) using the EO Browser, for several rainy days of the autumn 2021 and found out the areas where large volumes of rainy water is accumulated. This helped us to choose the locations where we set up our 7 “meteorological stations”.

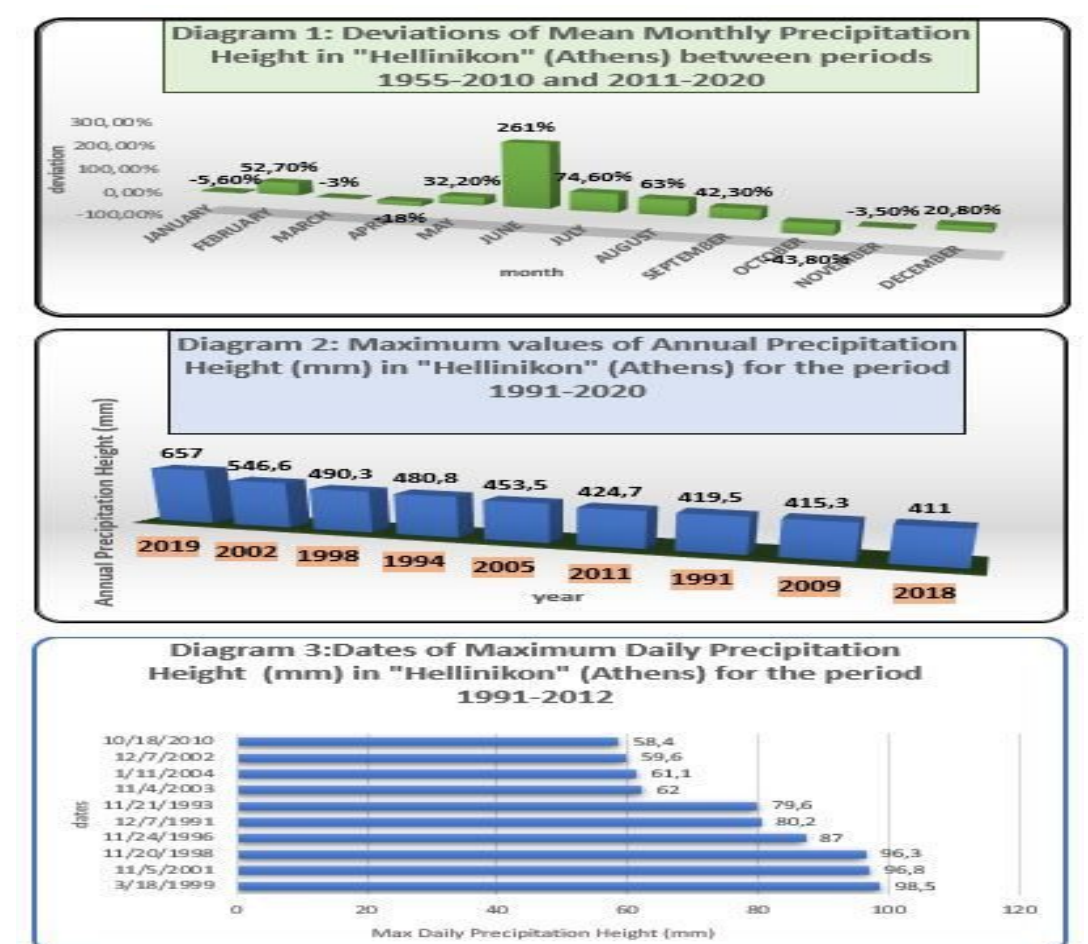
Figure 2: Graphic representation of processing data from Hellenic National Meteorological Service

I. There are significant deviations for the mean monthly precipitation height between the decade 2011-2020 and the normal values of the period 1955-2010 (diagram 1).

II. There are 9 positive deviations from the mean annual precipitation height (400 mm) during the period 1991-2020. The majority of the years with such an increase in rainfall is after the year 2000 (diagram 2).

III. The 10 bigger values of the maximum daily precipitation height for the period 1991-2012 are depicted in diagram 3. Most of them exceed the mean monthly precipitation height!
